Increased Pump Hours Doesn't Mean Increased Electricity Costs

Overview

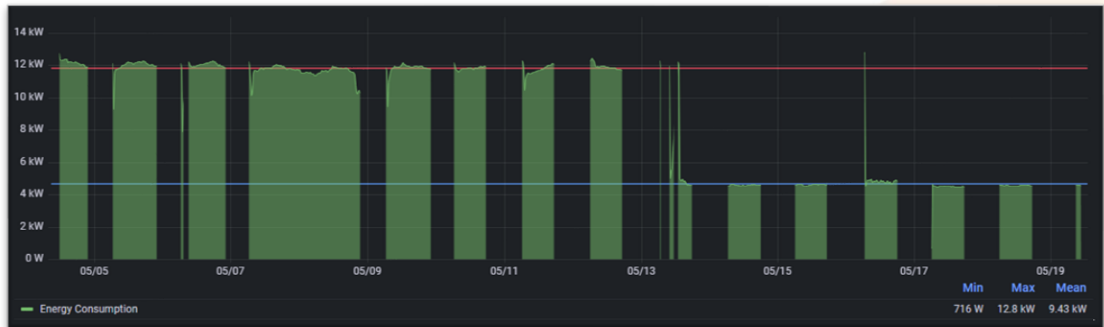
Base Period (pre installation)	Adjusted for normal Maintenance Period	Post Installation	Variance
Average kW	11.8	11.8	4.65	▼ 60.59%
Daily operating Hours	14	10	20	▲ 100.00%
Average Daily kWh	168.03	118	92.64	▼ 21.49%

The base line numbers were adjusted for normal maintenance mode operations where the pumps only operated 10 hours a day whilst there were no guests. During the pre installation period, Poolwise Indonesia and the hotel experimented with various different operating hours. Whilst pool water quality was maintained the cost of the maintenance increased proportionality.

Working with EES, Poolwise Indonesia were able to increase operating hours to 20 hours a day so as to maintain sufficient turn but not increase the total daily operating costs. This involved calibrating the pumps via the POWERees drives in order for them to work with optimum efficiency within the designed system, and included parameter thresholds being set and maintained so that any abnormal occurrences, such as blocked or burst pipes, were identified and the pump stopped so as to protect it from burning out.
